A Study Of The Vertical Forces On The Rear Axle In A Fairmont MT19A

by Bill Owen

An Improved Chain Drive For The Fairmont MT19

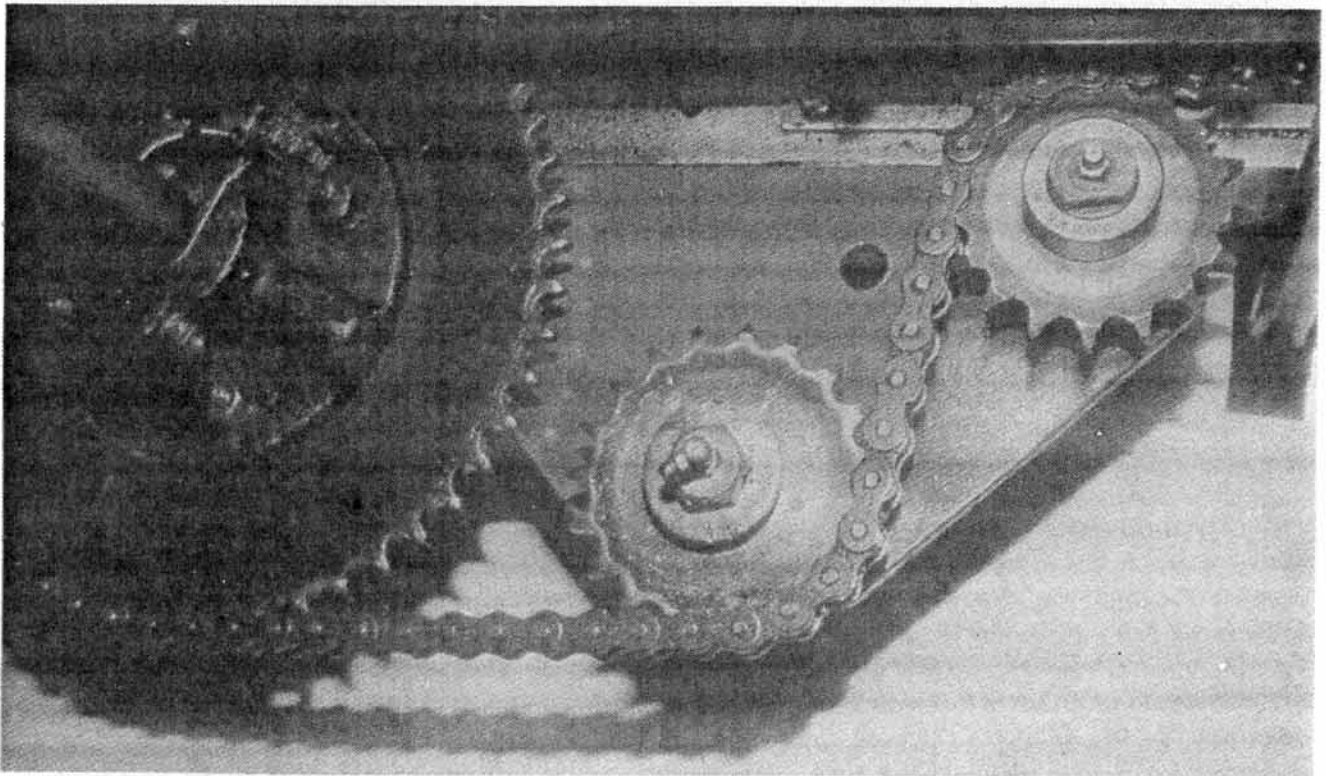
Dual idler Bracket assembly on MT19.

A second way is to add a second idler sprocket on a bracket such that the chain comes off the bottom of the rear sprocket nearly horizontally and travels a very short distance to the lower sprocket. The chain then goes up and over the upper sprocket and follows pretty much the original path to the transmission sprocket. The second arrangement keeps the chain at or above the bottom level of the rear sprocket for a fairly short distance so it will not have as much of a problem with picking up debris as with the first arrangement. Although the second arrangement requires a second idler sprocket, it looks like it is the best choice because it minimizes the amount of chain below the frame of the car.

ing was all the measurement system indicated. The same lack of bending was found during repeated tests of rapid deceleration in first gear. There is no question this dual idler chain drive eliminates the excessive vertical bending force on the MT19 rear axle.

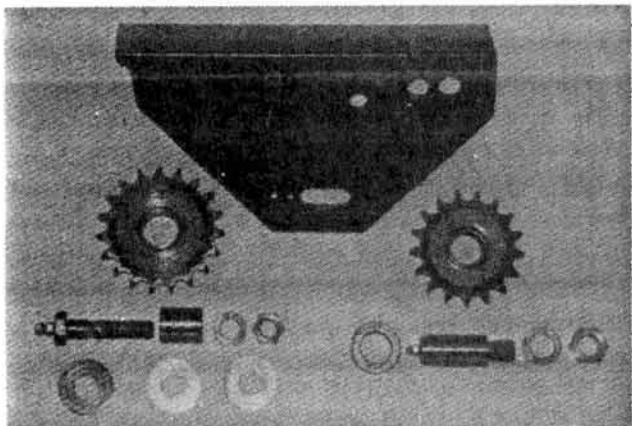
Dual idler bracket parts.

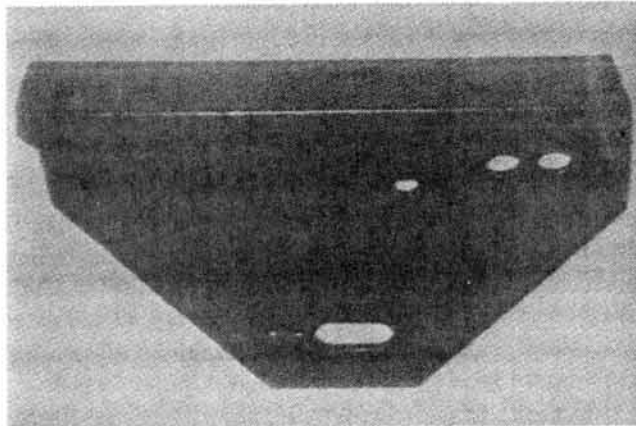
Dual idler bracket.

To test this idea out, I made a bracket for the dual idler sprocket arrangement using 3" by 6" by 5/16" angle iron. (Please see the picture of this bracket with the idler sprockets mounted on it.) In order to adjust for chain wear, the lower sprocket hole is elongated by 1", and for the upper sprocket there are two spaced holes 1" apart. (Please see the scale drawing and the picture of the bracket.) The original idler sprocket on my MT19 has 19 teeth, and the threaded portion of the 5/8" diameter shaft is nearly 2" long. This idler shaft is installed in the

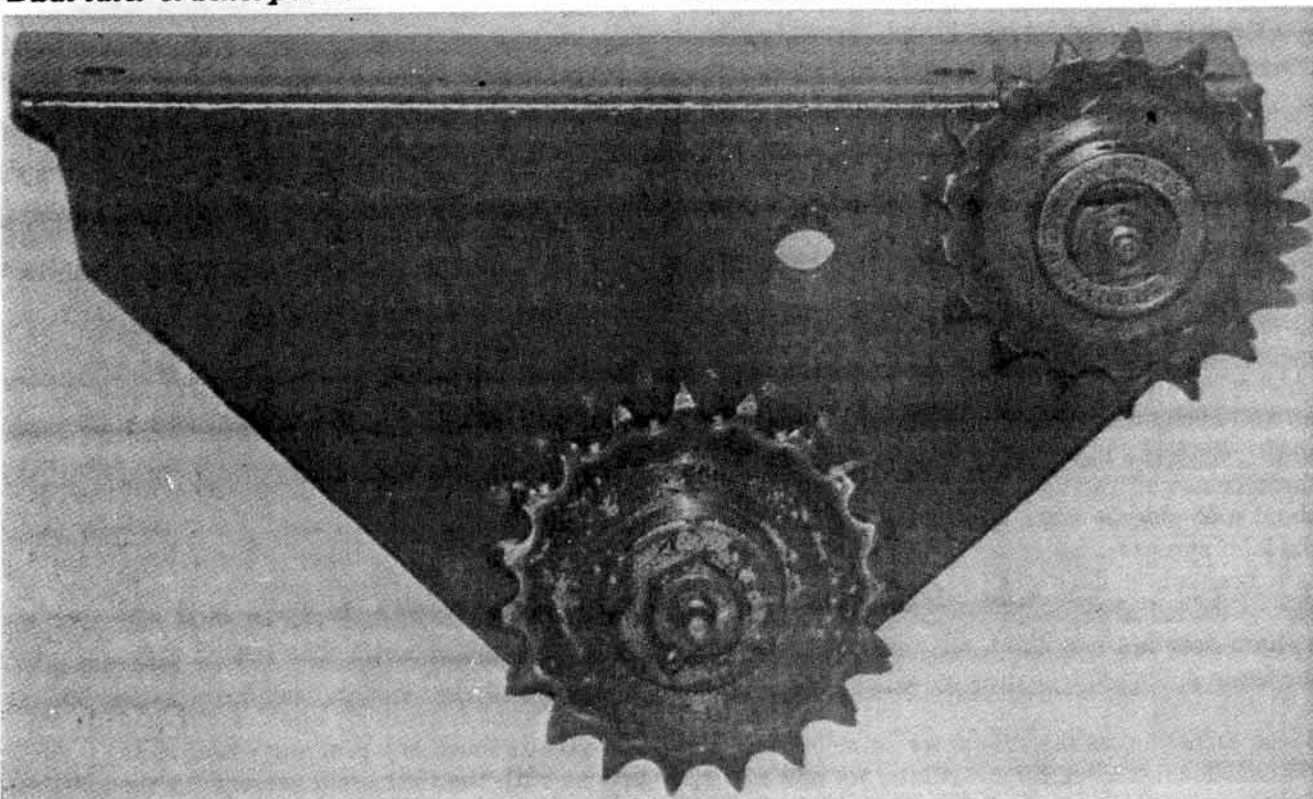
Assembled dual idler bracket.

lower idler slot with a heavy washer on both sides of the elongated slot along with a lock washer and nut to secure it. A new 3/4" Browning tightener shaft and a 17-tooth idler sprocket are installed in one of the two fixed mounting holes for the upper idler sprocket.

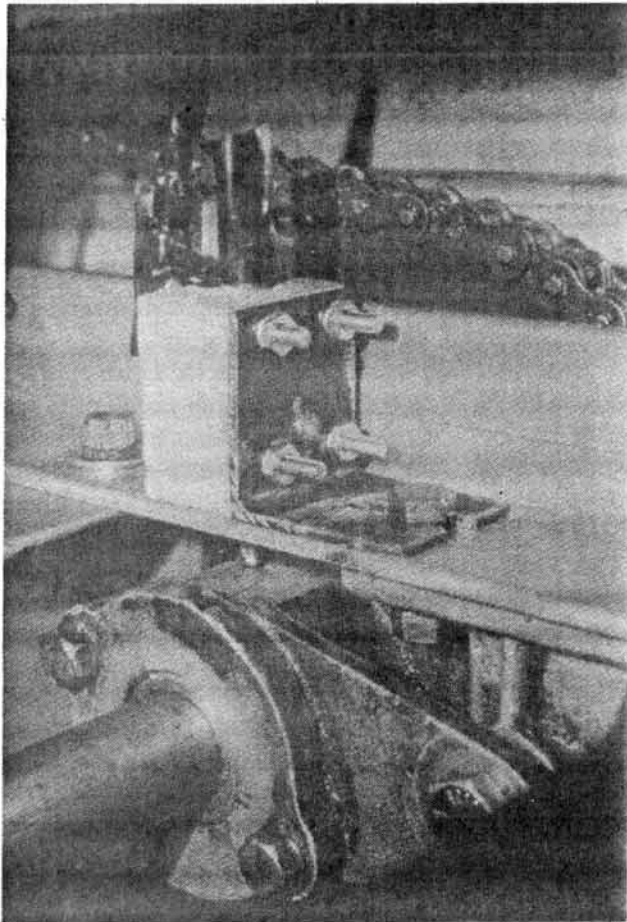
Center bearing position sensor.

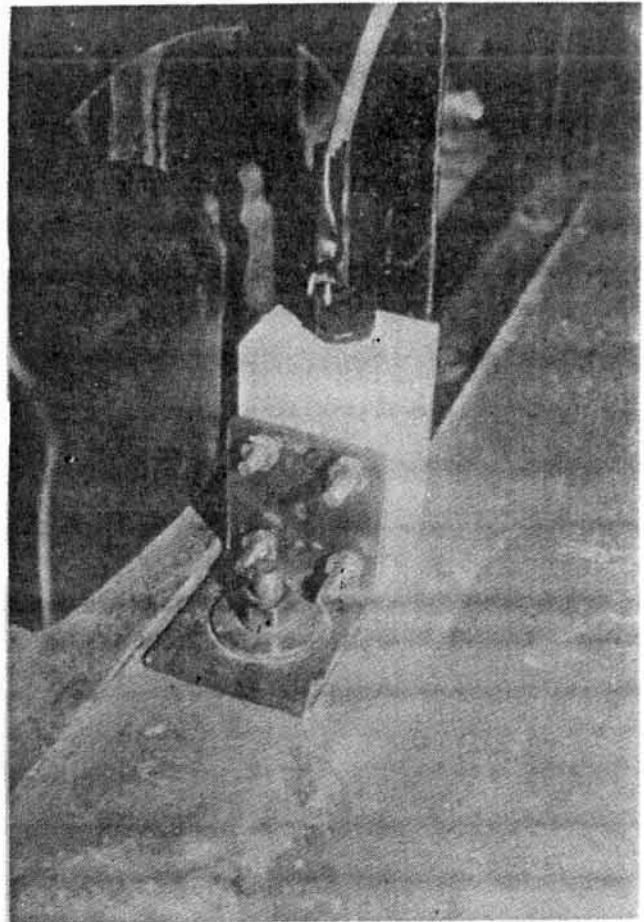
Left wheel bearing block position sensor.

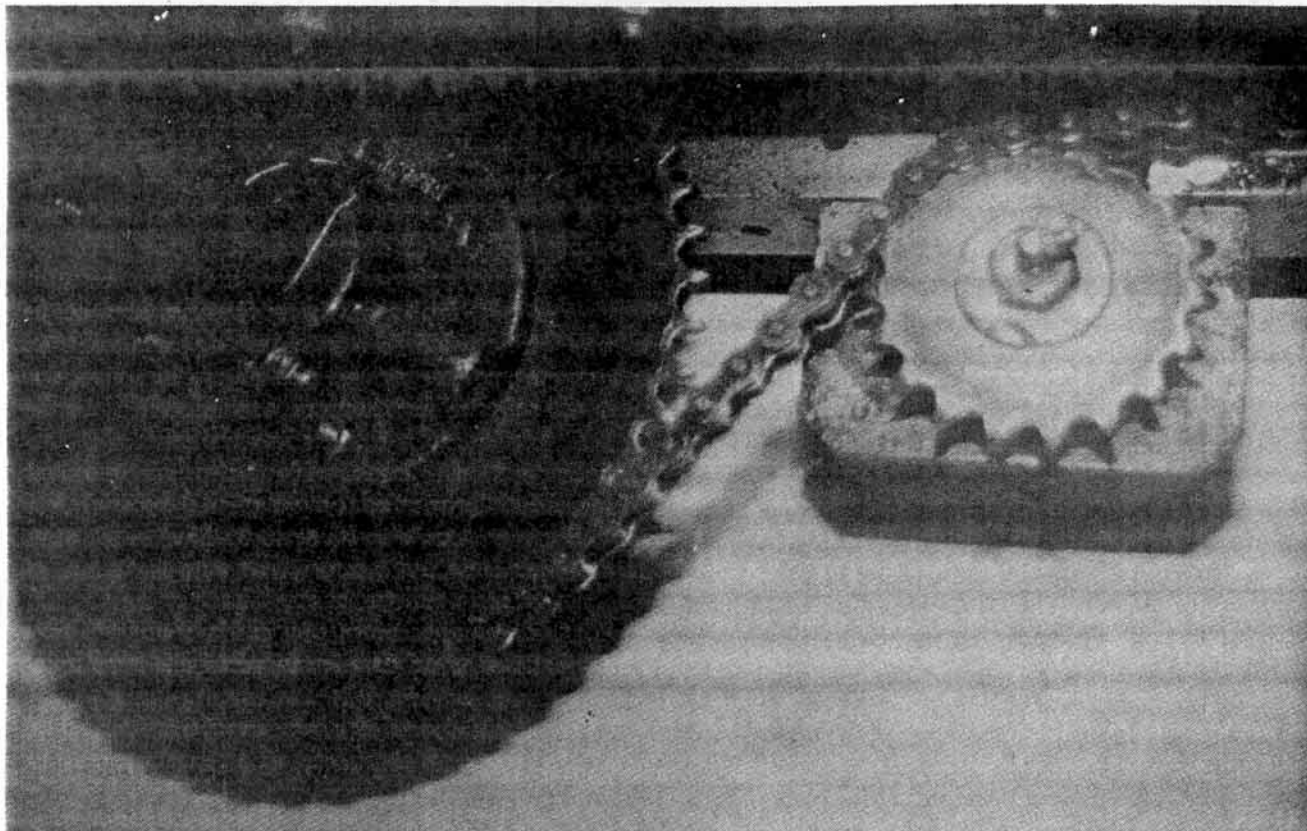
Original Fairmont idler sprocket on MT19.

tal direction. Off the bottom of the rear sprocket, however, the chain is routed up and over the idler sprocket, which causes the chain to come off the bottom of the rear sprocket at about a 45-degree angle upwards. (Please see the picture of the MT19 chain drive taken under the right side of the car.) This means whenever the bottom of the chain is under tension, the axle sees both a forward horizontal force and an upwards vertical force. Since the angle is about 45 degrees, these forces are nearly equal. A properly adjusted center bearing and support bracket, which is located right next to the sprocket, very effectively counters the forward horizontal force. This prevents any significant bending of the axle in the forward direction.
